AN SEM ANALYSIS OF BEARING FAILURE DUE TO ELECTRICAL ARCING

National Aeronautical Establishment

AERONAUTICAL NOTE
NAE-AN-3
NRC NO. 20936

OTTAWA
JANUARY 1983

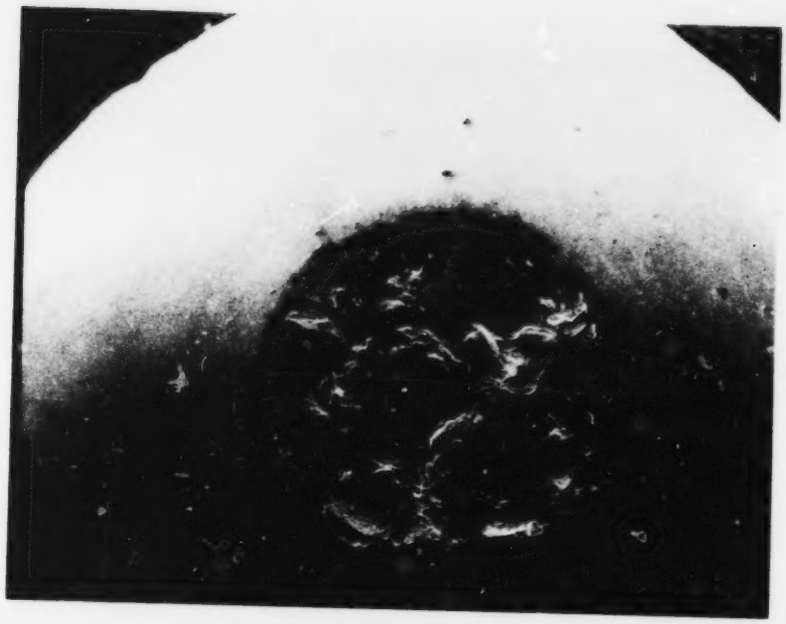
Removal of the balls from bearing "A" indicated a dark gray discolouration of the balls and the inner and outer races. Although, to a great extent the surfaces of the balls were relatively smooth and undamaged, all but two of the 16 balls exhibited one or more relatively large craters on their surfaces, ranging from 1 to 3 mm. in diameter, Figure 1. Where several craters were observed on one ball, they appeared in some instances to be circumferentially aligned on the surface, as shown in Figure 2. At higher levels of magnification of the SEM, globules or beads of what appeared to be previously molten metal were found in the craters on the surfaces of the balls from this bearing, Figure 3. Although some 43 craters were counted on the surfaces of 14 of the balls from this bearing, only three rather large cratered areas were observed on the outer race. Two of these were located some 11.0 mm apart, and measured approximately 3 and 4 mm in length. One of these is shown in Figure 4. A larger cratered area measuring some 4 by 7 mm was located diametrically opposite from the region of the other two craters in this outer race. The race in the inner ring of this bearing exhibited no comparable cratered areas.

FIG. 1: TYPICAL CRATER ON BALL FROM BEARING "A"

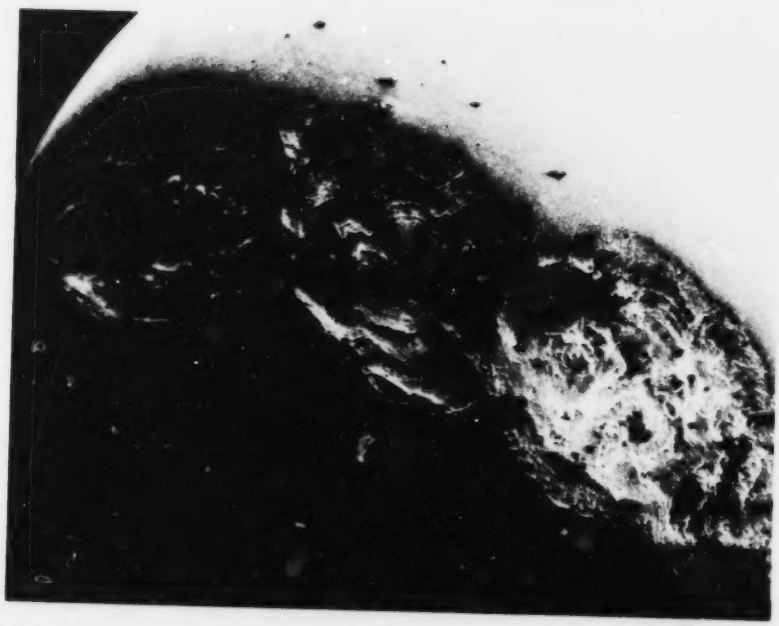
FIG. 2: CRATERS CIRCUMFERENTIALLY ALIGNED ON BALL, BEARING "A"

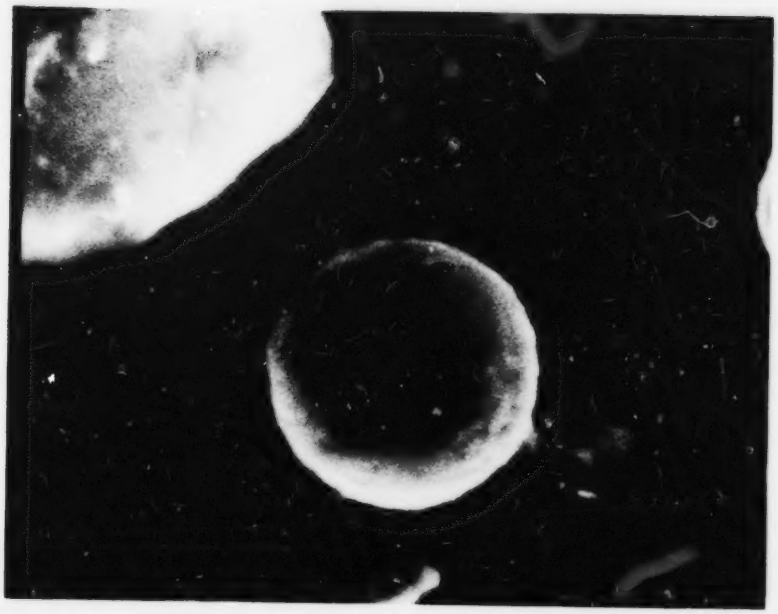
FIG. 3: GLOBULE OF MOLTEN METAL, BEARING "A"

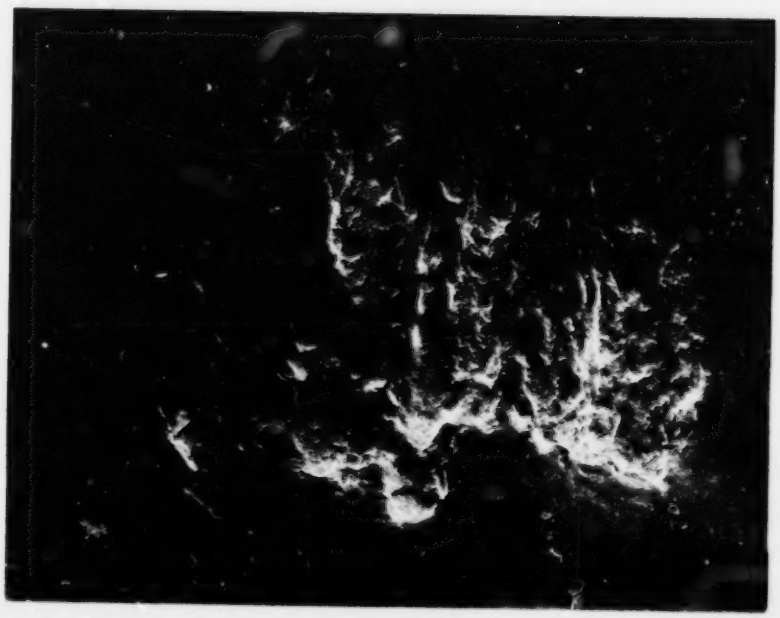
FIG. 4: DAMAGE TO RACE, BEARING "A"

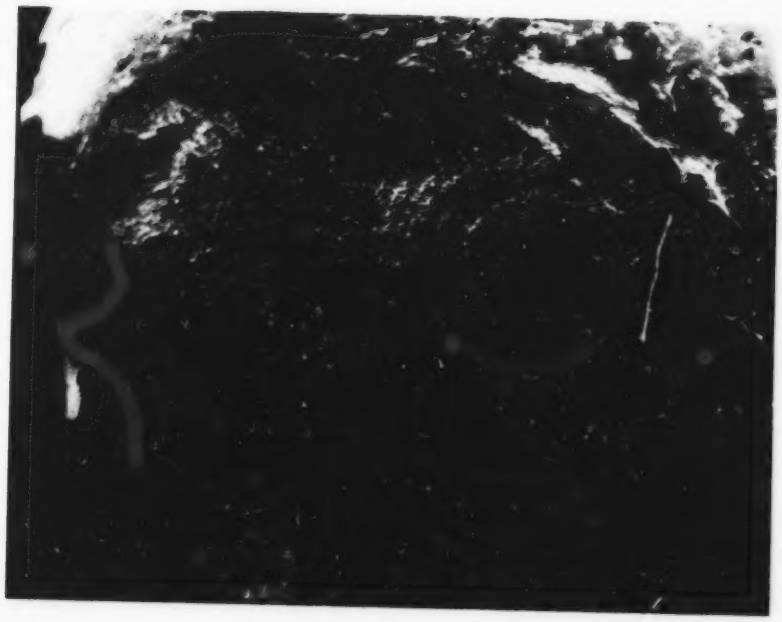
interest were small fracture surfaces with a series of coarsely spaced fatigue striations emanating from the edge of the pools, as illustrated in Figure 8. The direction of fatigue crack growth is indicated by the arrow in this figure. Since the edge of the pool appears to be the initiator of the minute fatigue crack, it would appear that the formation of the crater could be considered to be the primary damage, and that small areas of the surfaces of the balls had flaked off under the influence of cyclic stresses. Examination of such striated areas at higher magnifications revealed no evidence of finely spaced fatigue striations, so that it is concluded that only some 20 stress cycles were required to create the fatigue fracture surface (Figure 8) formed by the fatigue crack some 4.0 mm in length. Thus the fracture could be described as resulting from low cycle fatigue produced by relatively high levels of cyclic stress. Minute globules, such as that illustrated in Figure 8, found in the depressions on various balls from this bearing, indicate that microscopic melting of the metal had occurred in numerous locations on any given ball.

FIG. 8: LOW CYCLE FATIGUE FRACTURE ON BALL SURFACE, BEARING "B"

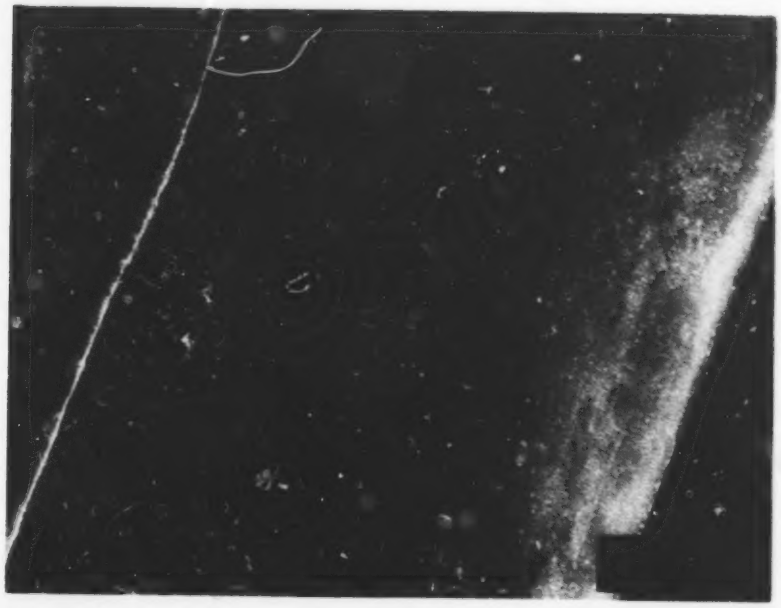
Both inner and outer races of bearing "B" show evidence of damage over their entire circumferences on one edge of the races, arrows Figure 9, as well as areas of major damage in the form of severe pitting in the races, Figure 10.

FIG. 9: CIRCUMFERENTIAL RACE DAMAGE, BEARING "B"

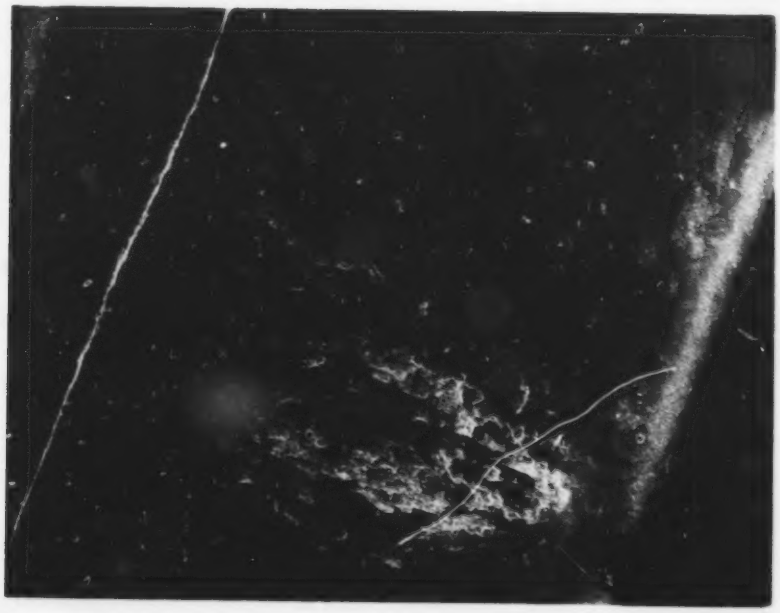
FIG. 10: RACE DAMAGE, BEARING "B"

Remedial action could involve the introduction of a conductive lubricant into the clutch, or some mechanical means of maintaining zero electrical potential between the inner and outer rings of the bearings. While bearing "A" shows evidence of few (43) relatively large discharges, the balls from bearing "B" bear evidence of numerous small discharges. Unfortunately, it could not be determined which of the two bearings was immediately adjacent to the generator, or whether proximity to the generator influenced the nature of the electrical discharges.
